# Marine aggregate dredging

## in Kollafjörður, Iceland. Multibeam survey 2002 – a basis for comparison

Árni Þór Vésteinsson, Björn Haukur Pálsson, Níels Bjarki Finsen, Sigríður Ragna Sverrisdóttir Icelandic Coast Guard and Bryndís G. Róbertsdóttir National Energy Authority

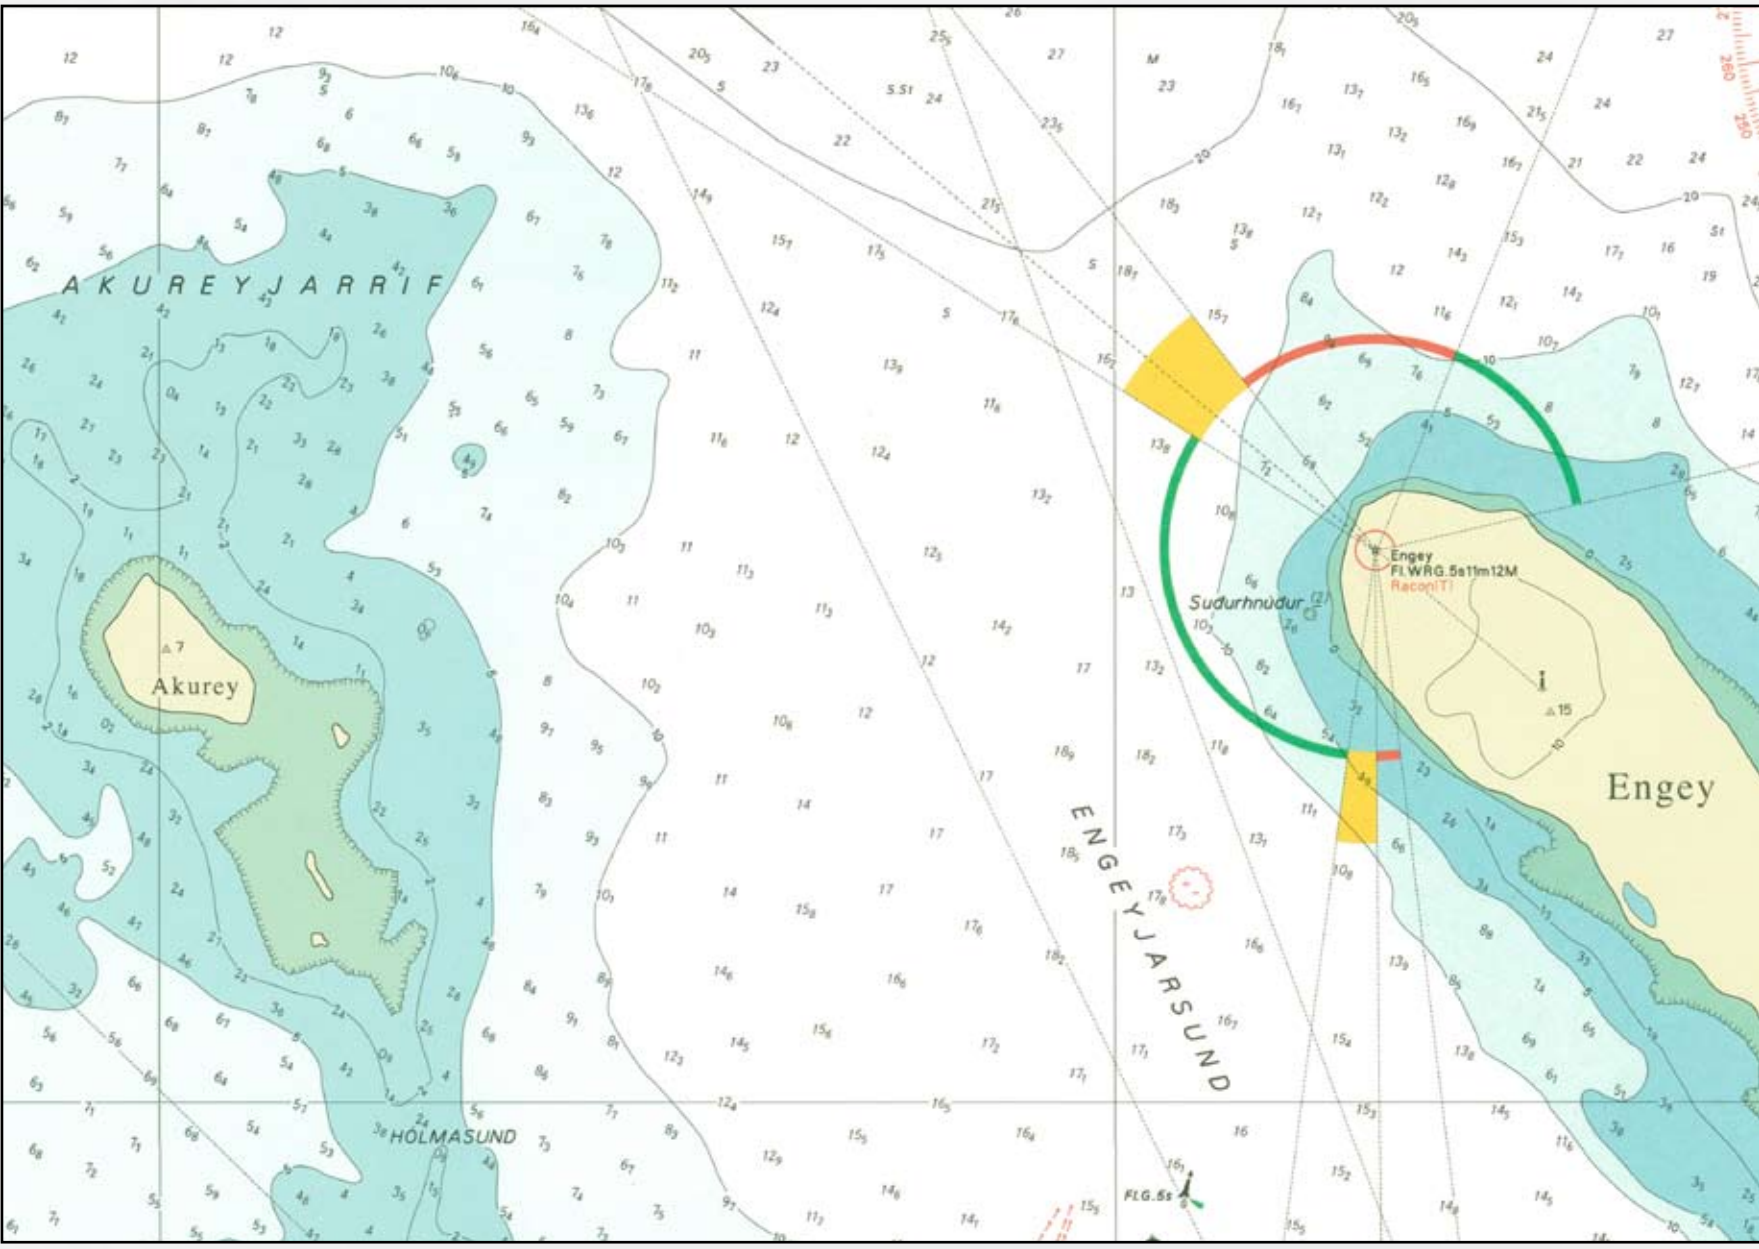
The Akurey aggregate dredging site. From chart No. 362 (INT 1113) Reykjavík, Engeyarsund - the entry to Reykjavík harbour in 1996. Depths in meters and decimeters.
